Focused Site Inspection Prioritization Report

Belvidere Municipal Landfill #2

USEPA ID No. ILD 000 605 113

September 10, 1995

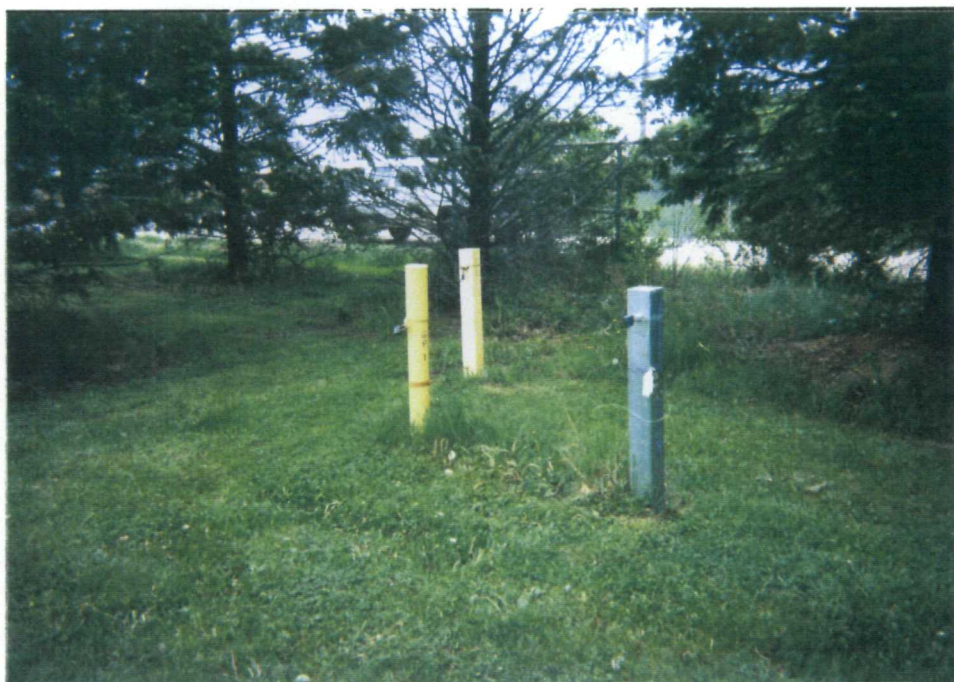
Date: May 18, 1995
Time: 0937
Photo Taken By: J. Noyes
Photo Number: 3
Site/ILD No.: Belvidere
Municipal #2/
ILD000605113
Direction of Photo: Facing
Northwest
Description: Monitoring
wells located at the SW
corner of the site near the
IDOT facility.

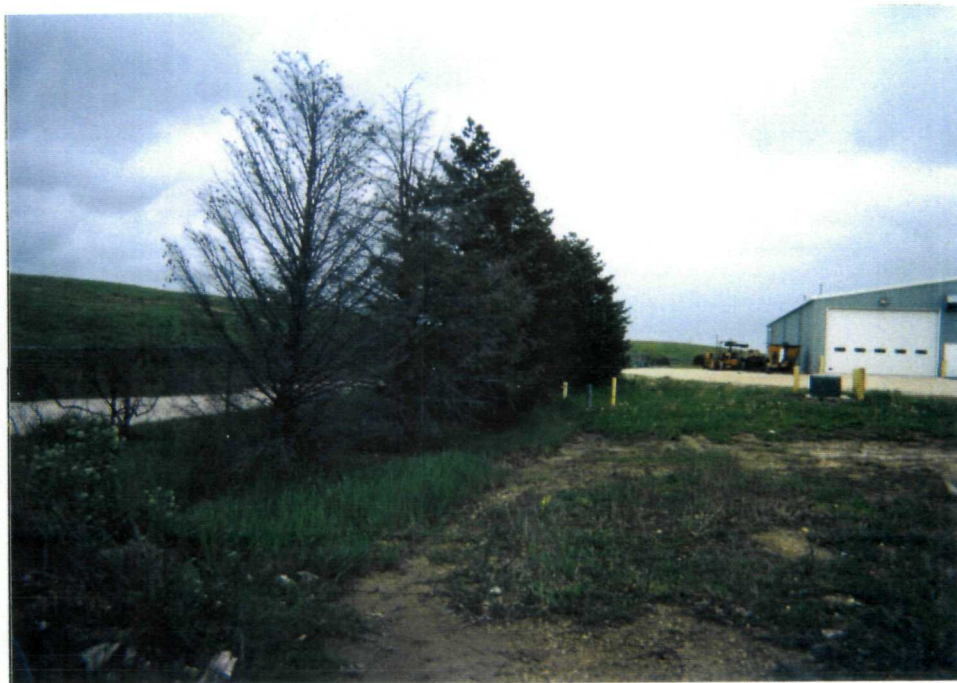
Date: May 18, 1995
Time: 0944
Photo Taken By: J. Noyes
Photo Number: 4
Site/ILD No.: Belvidere
Municipal #2/
ILD000605113
Direction of Photo: Facing
East
Description: Two dead
pine trees with three
monitoring wells in the
background.

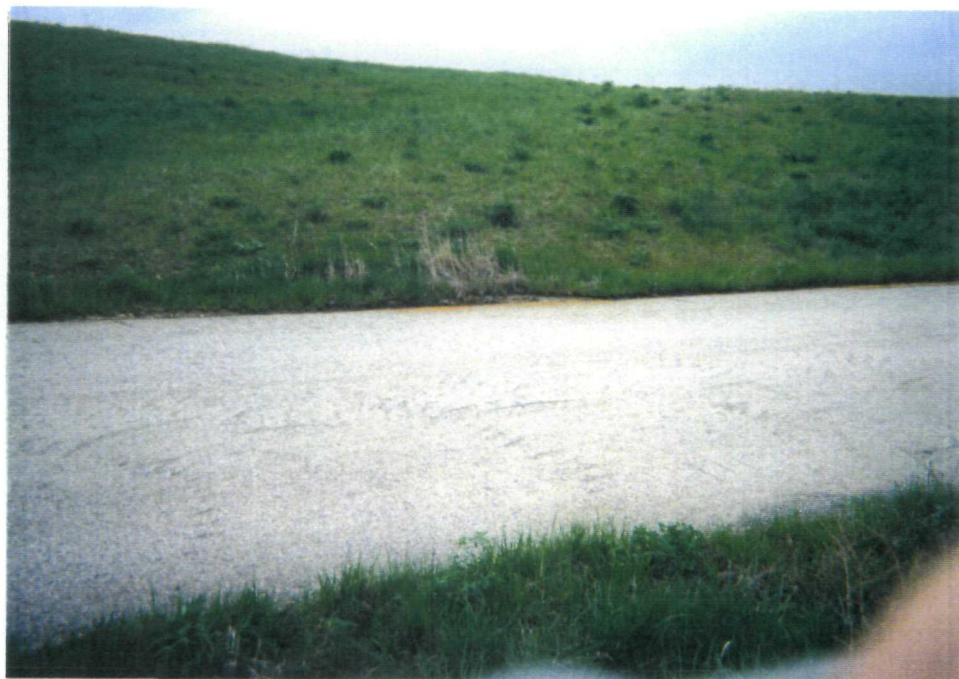
A leachate ponding area was seen near the end of the haul road on the southeastern portion of the landfill. The leachate had a very strong sulfur odor, but did not appear to be migrating offsite. Leachate seeps were also noted on the eastern slope of the landfill and in two locations on the northern slope of the landfill. Water was seen ponding on the northern edge of the landfill below a seep near the western corner. The water appeared to have a sheen, but had no odor. Vegetation on the landfill did not appear to be stressed. The western edge of the site was obscured by tall shrubs growing inside the fence line. A nursing home is located approximately 1,200 feet south of the landfill. Directly south of the site, the state and county highway departments have maintenance facilities on an adjacent property. Highland Memorial Funeral Home, Inc., is located west of the landfill.

Date: May 18, 1995
Time: 0956
Photo Taken By: J. Noyes
Photo Number: 6
Site/ILD No.: Belvidere
Municipal #2/
ILD000605113
Direction of Photo: Facing
North
Description: From fence,
looking at leachate seep.

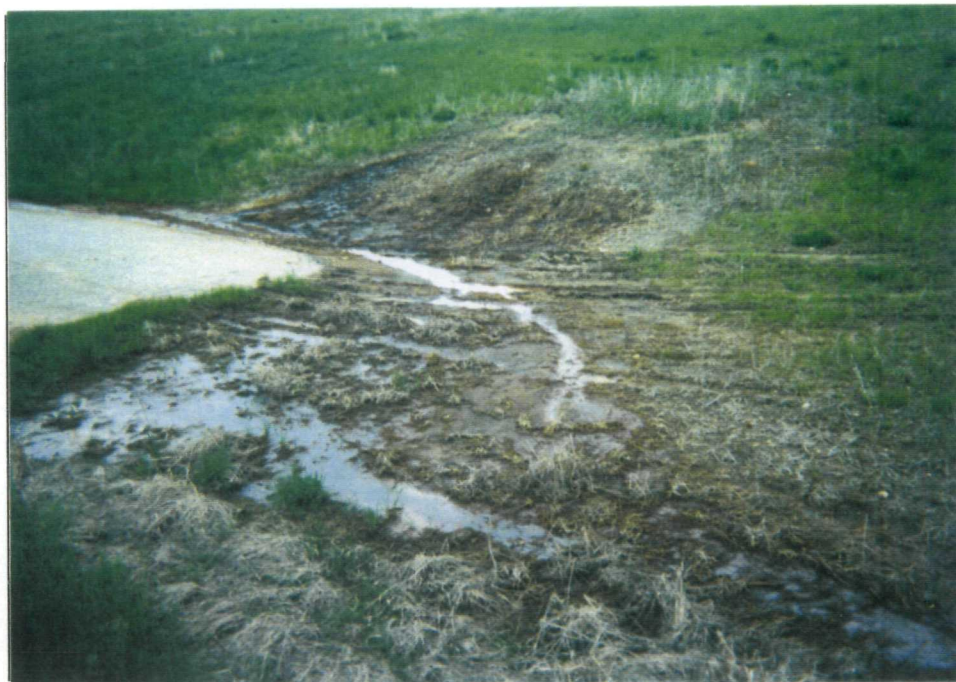
Date: May 18, 1995
Time: 1000
Photo Taken By: J. Noyes
Photo Number: 7
Site/ILD No.: Belvidere
Municipal #2/
ILD000605113
Direction of Photo: Facing
North
Description: Ponding leachate,
stressed vegetation, foul odor.
